NPDES Inspection Report

Permit # WAR05I001

Omak Forest Products, LLC

September 15, 2016

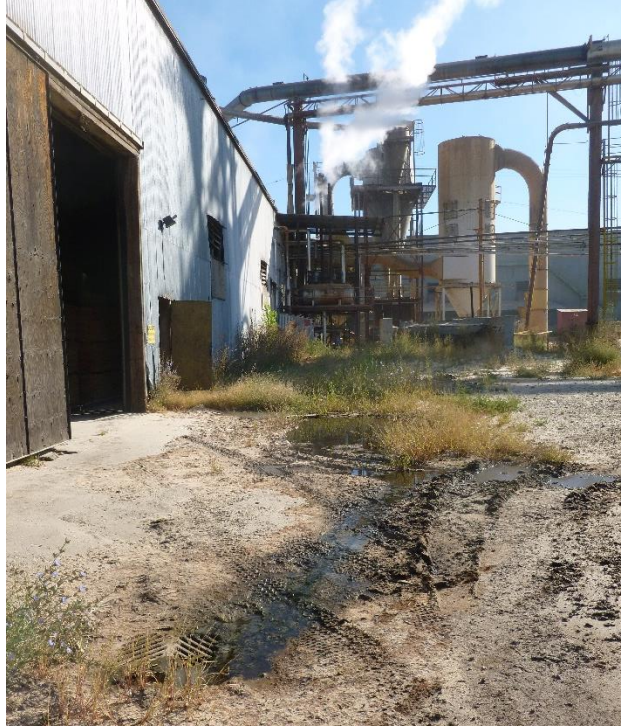
- I inspected the tanks and pumps (**Photo 28**) used to control steam condensate from the plywood plant. Mr. Epperson said that the pumps were leaking and I observed steam condensate on the ground (**Photo 29**).

I inspected the tanks and pumps used to collect and control steam condensate on the south side of the plywood plant (**Photo 28**). Mr. Epperson said that the pumps were leaking and I observed steam condensate on the ground (**Photo 29**) with exposure to stormwater.

Photo 29 / P1020662 – Steam condensate overflow from the plywood plant. This is a cropped version of the original photograph.

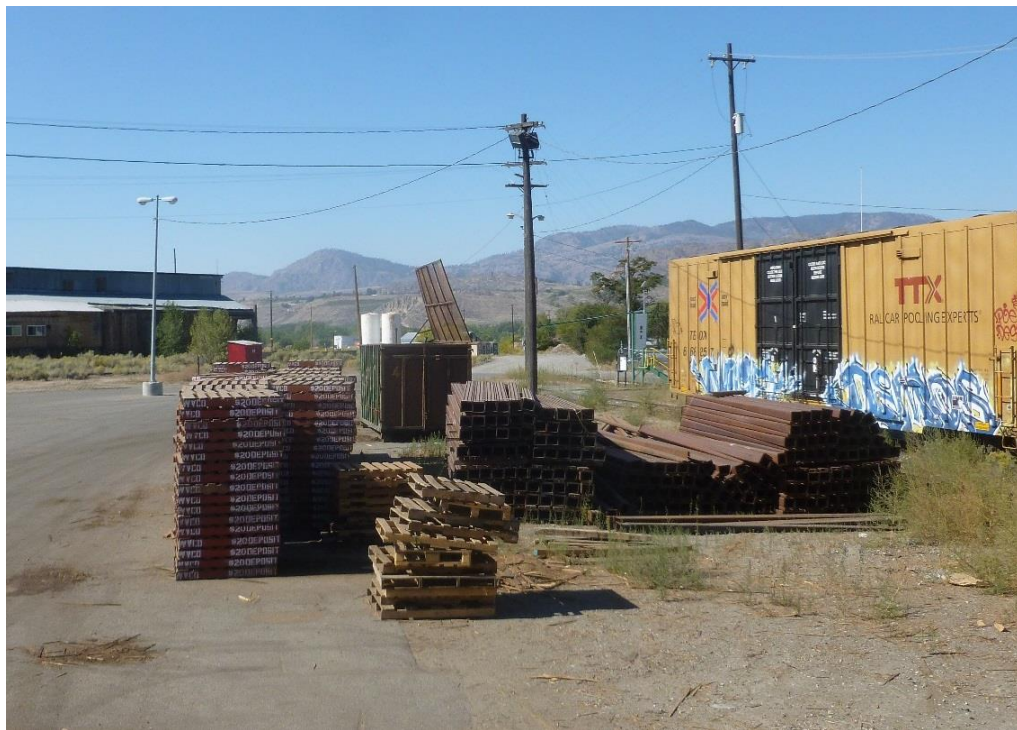
During the inspection, I observed multiple dumpsters (**Photos 14-16 and 30**) that were open and not in use.

Photo 30 / P1020744 – Westerly view of stacked metal rods, wood pallets and an open dumpster in the parking lot of the plywood plant. This is a cropped version of the original photograph.

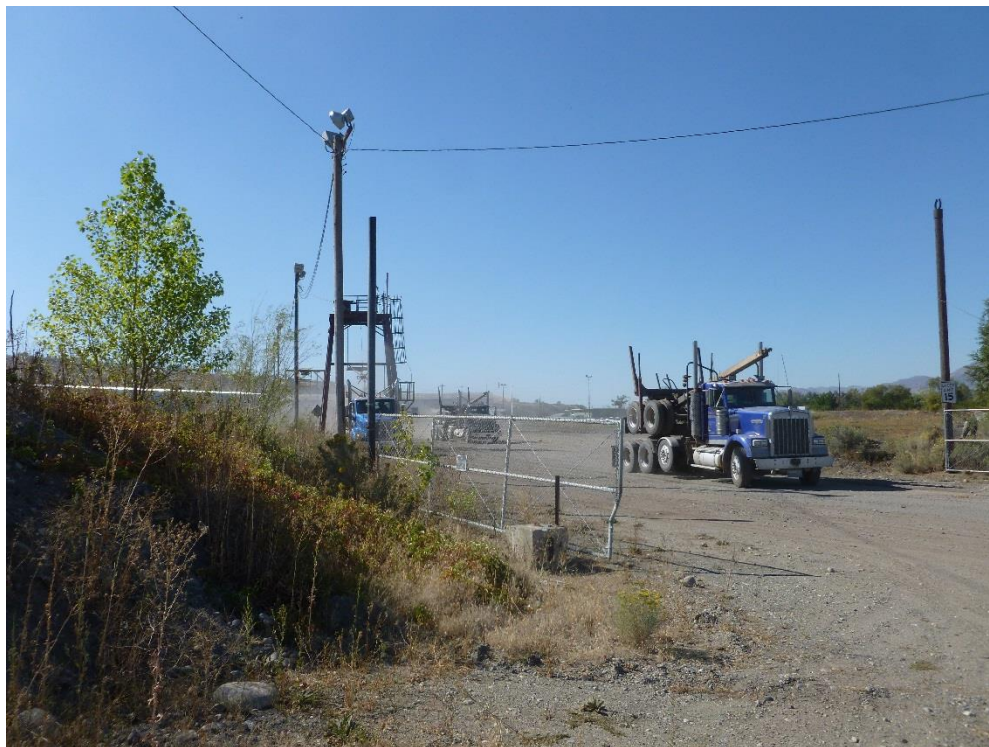
At the unpaved delivery entrance to the facility, I observed the generation of dust (**Photo 32**) from industrial vehicle traffic and sediment tracked off-site onto Omak Avenue (**Photo 33**).

Photo 32 / P1020734 – Southerly view of the delivery entrance from Omak Avenue. Dust appears in the air in the background.

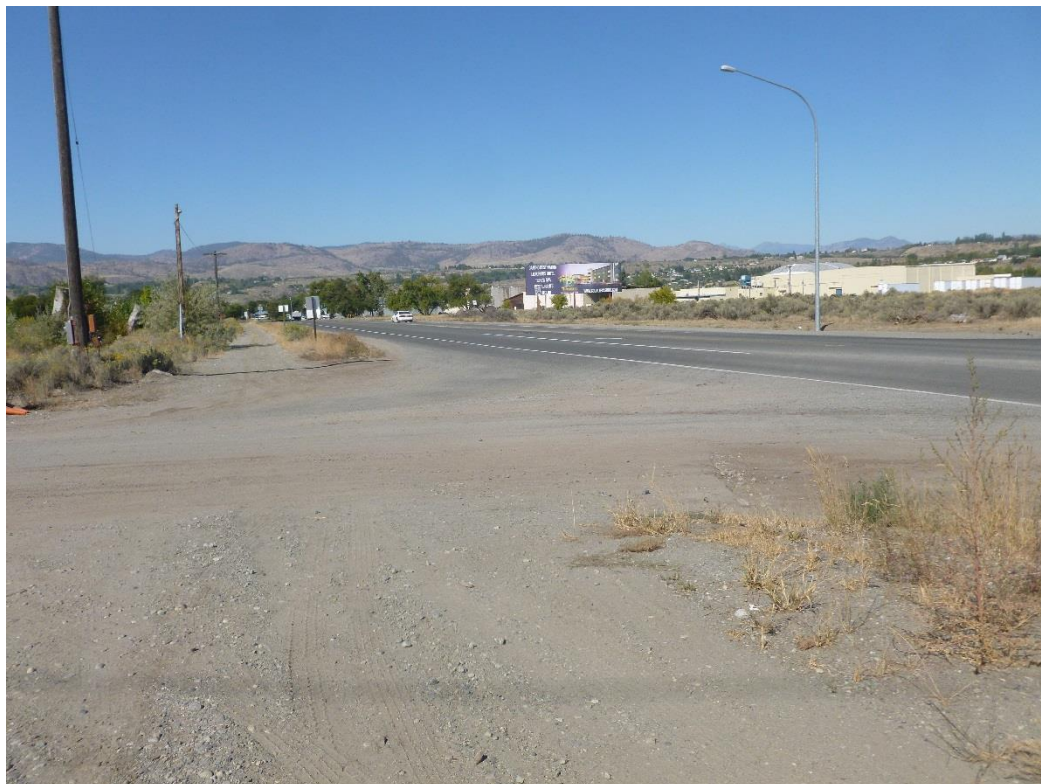
Photo 33 / P1020735 – Westerly view of the delivery entrance from Omak Avenue
